DIVEX HSE ALERT

HSE Alert No. HSE001-2006

Hyfex Fire Extinguisher Refill Kits
Part No's SE4816 and SE4817

DATE	05/05/06	COUNTRY:	EGYPT	LOCATION:	DECOMPRESSION CHAMBER
-------------	----------	-----------------	-------	------------------	-----------------------

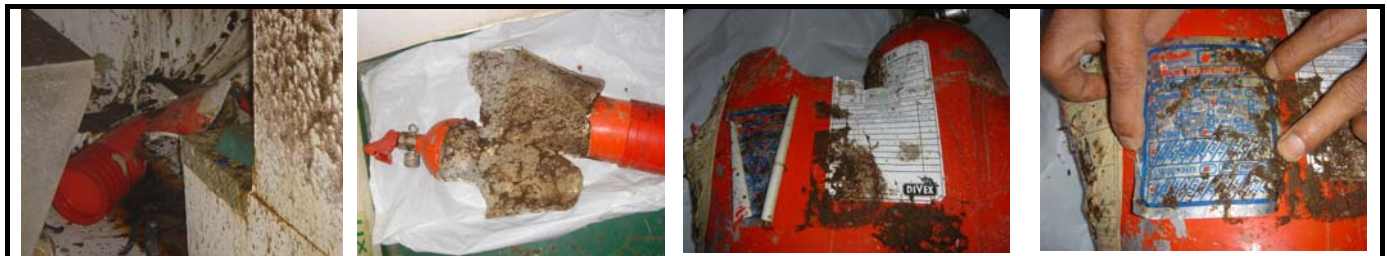
An installed Hyfex Hyperbaric Fire Extinguisher has recently catastrophically ruptured inside a decompression chamber. Fortunately no personnel were injured as a result of the incident and only minor damage occurred to the interior of the decompression chamber. The photographs below indicate the potential severity of the failure:

Investigation has revealed that the interior wall of the fire extinguisher was badly corroded, in places the wall thickness was only approximately **2mm thick**. Typically wall thickness should be approximately **4.2mm and 6.3mm thick based on the type of cylinder**.

The contents of the ruptured extinguisher seem to indicate that the wrong type of foaming agent has been used and that it has had a significant influence on the high levels of corrosion. Initial appearances are that a "protein based" foam agent such as "bull's blood" with a high level of iron content may have been used. This is difficult to quantify at present.

- Clients (users) need to refill Hyfex Extinguishers with Divex AFFF Refill Packs (SE4816 (3Ltr) and SE4817 (7.5 Ltr));
- Users must ensure their sub-contractors are fully aware of technical requirements and hold the necessary factory / manufacturers training.
- Issue Divex HSE Alert to all trade associations (e.g. IMCA, ADC (UK) and ADC (USA));
- Issue Divex HSE Alert to all known purchasers of Divex Hyfex Extinguishers;
- Distribute Divex HSE Alert to all Divex locations.
