COBRA Guidance Note

The purpose of this Product Guidance Note is to share various (mostly minor) issues which have occurred recently and provide information relating to future changes.

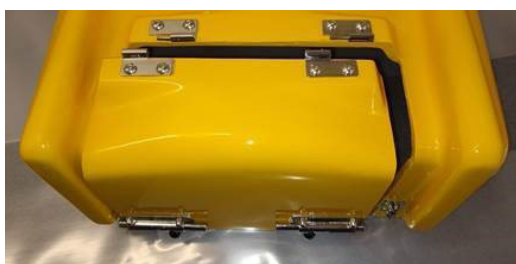
A number of back covers have been supplied with alternative hinges fitted. This causes the door to remove to the right, rather than the left. A number were also supplied with the hinges fitted upside down. Although this has no immediate effect on the functionality of the set, a potential problem exists if a spare door is required.

Figure 1 - Correct Orientation

All spare doors are supplied with a full set of hinges, so it will be possible to fit the replacement door in all cases.

For users wishing to standardise their sets, the correct hinge pt. no. DB5004141 is available from JFD on request.

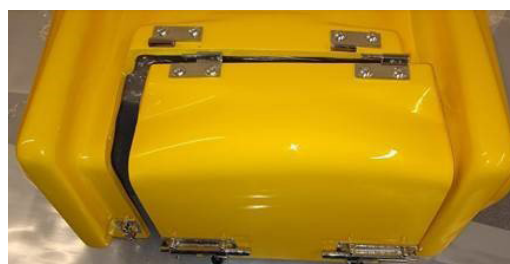
Figure 2 - Incorrect hinges and fitted upside down

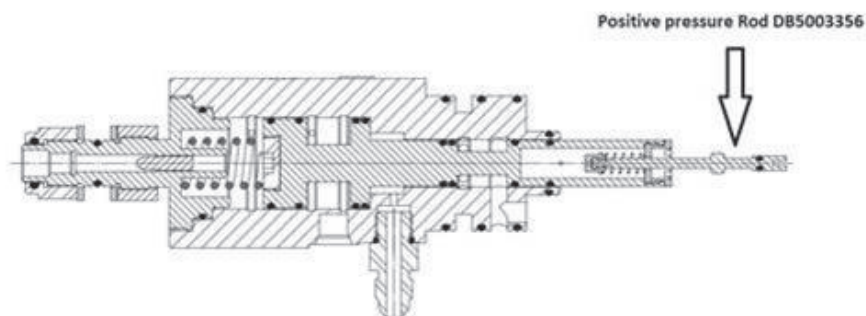
Figure 5 - Piston Assembly Showing Positive Pressure Rod

Various reports have been received relating to bending of the positive pressure rod DB5003356.

Likely reasons for bending to this rod are adjusting the demand valve setting via the diaphragm opening or manually purging the set to drain the cylinders more quickly. If either of these techniques is used, care must be taken to not damage the positive pressure rod.

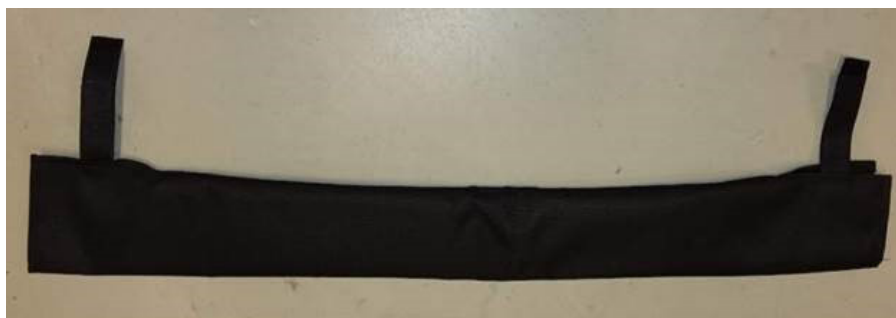
Figure 6 - Breathing Hose Cover, DB5002921

User requested additional protection for Breathing Hoses.

JFD can now provide Cordura covers for COBRA breathing hoses, pt. no. DB5002921

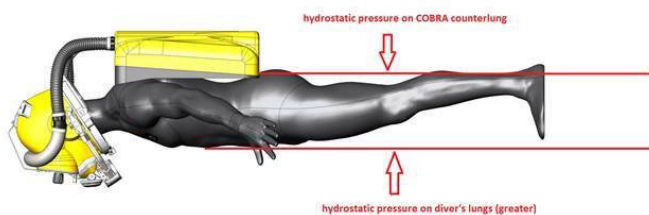
Users have reported increased breathing resistance when using COBRA in various orientations.

This is a well understood characteristic with all rebreathers. A proportion of the required breathing effort is caused by the pressure difference between the user's lungs and the current relative position of the rebreather counterlungs. For example, if a diver (using COBRA) is on his front, the counterlungs are higher in the water column i.e. at a lower pressure than the diver's lungs. The diver will have to work harder to fill his lungs with gas. Conversely, if the diver is on his back, the counterlungs will be at a higher pressure and the diver may well require extra effort to exhale. Other positions, of course, lie between these extremes.

Figure 10 - Diver Face Down, Easy Exhale, Harder Inhale

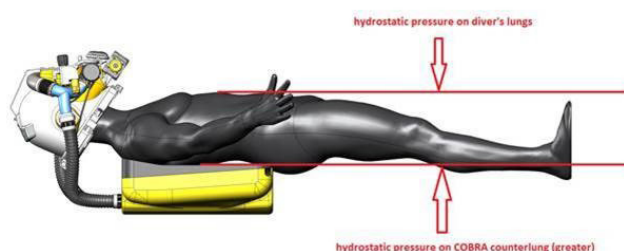
Figure 11 - Diver Face Up, Easy Inhale, Harder Exhale
