COBRA Guidance Note

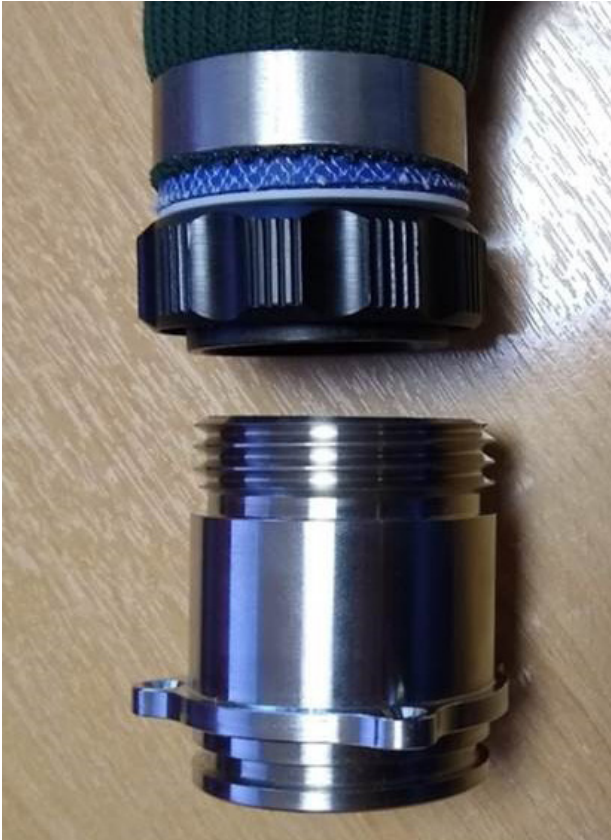
Figure 1 - Backpack Connector and Hose End

In all the reported cases, JFD believes that the hose nut was not fully engaged with the thread on the backpack / helmet connector. Due to the stowage / working arrangements in some bells, JFD understands that it is necessary to fit the breathing hoses to the backpack with the connectors facing away from the user. If this is the case, it is essential that the connection is properly inspected afterwards to ensure proper engagement.

The hose has a piston sealing arrangement. The hose nut should be fastened by hand, until it bottoms out and stops. At this point, the connection must be visually inspected to ensure full engagement. It is not necessary (nor is it recommended) to use any mechanical aid to tighten the hose nut. If the connection leaks with the hose fully inserted and the threads fully engaged, further tightening will not help rectify the leak. The connection should firstly be checked for correct engagement and then the o-ring and surface finish of the connector should be inspected for wear / damage.
