CAUTION NOTICE
DVX003-CAU-2013
 May 2013

Divex Caution Notice
 DVX003-CAU-2013

SAFETY ISSUE

Part Number DE109-850 – Mushroom Flap Valve

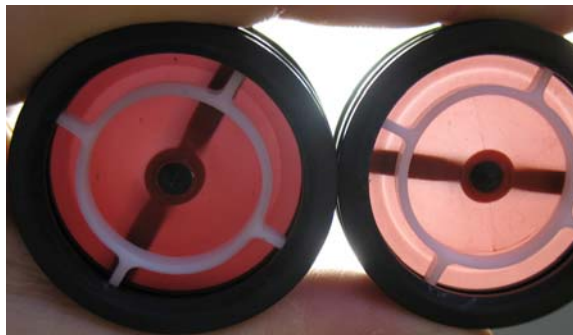
As a result of service work and in build testing completed by Divex it has been identified that Mushroom Flap Valve (DE109-850) made from red silicon has been changed by our Supplier. The original flap valve had a material thickness of 1.0 mm and the updated design has a material thickness of 0.5 mm. This can be seen in figure 1, which shows a noticeable difference between the original flap valve and a recent flap valve when they were both held up to the light.

Figure 1: Comparison between original and recent flap valves

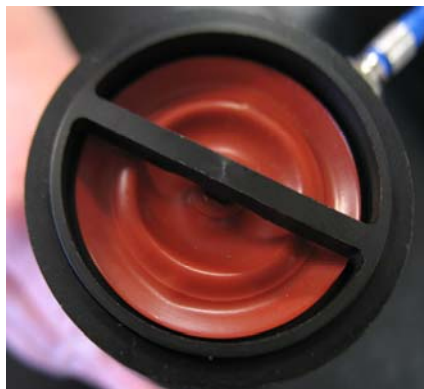
Figure 2: Original Flap Valve during testing

This reduction in thickness has led to the mushroom distorting slightly during testing, which may reduce the effectiveness of the seal, see figures 2 and 3. Please be advised that in all new builds Divex Ltd will only provide mushroom cartridges that have been tested and have found to seal properly.

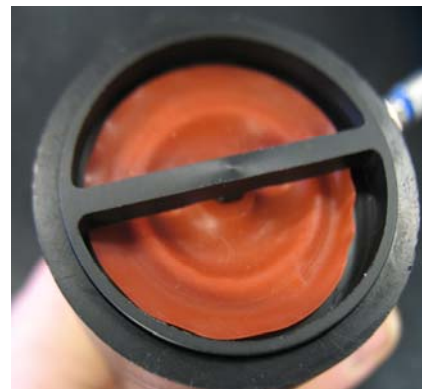
Figure 3: Recent Flap Valve during testing

For the present Divex advises all users to monitor the performance of the mushroom in your operations and advise if there is anything not operating as expected or causing concern.

Clients are requested to perform ongoing checks to ensure that the mushroom is maintaining its shape and function. Divex apologises for any inconvenience caused.
