COBRA Guidance Note

This guidance note applies to Mk2 COBRA sets only

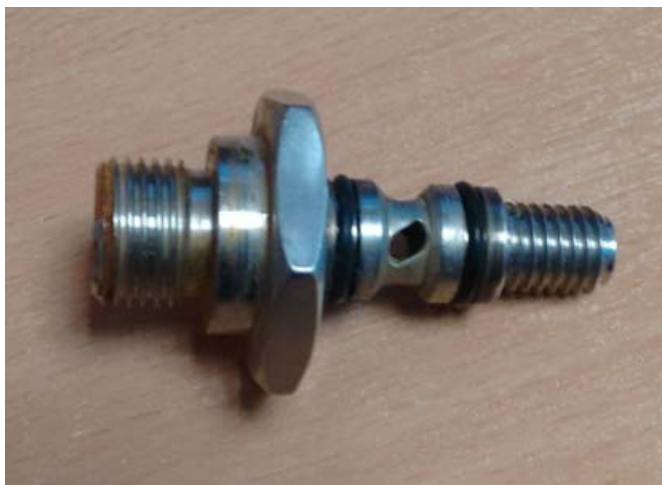
During recent service work at JFD, several instances of damage to the Hot Water Hose Spigot have been noticed (see Figure 1).

Figure 1 - Damaged Hot Water Spigot

The deformed radial holes indicate that the Nyloc Nut used to retain the Hot Water Hose (see Figure 2) has been over-tightened. Whilst the spigot would still allow hot water to flow in this condition, the chance of a failure and subsequent disconnection of the hot water hose is increased. If this occurred unnoticed during a dive, the COBRA scrubber would not function optimally if the set was activated.

The maximum torque applied to the Nyloc Nut must be limited to 6 ft-lbs.

The Nyloc Nut must not be used to screw in the Spigot/Hose assembly as one piece.

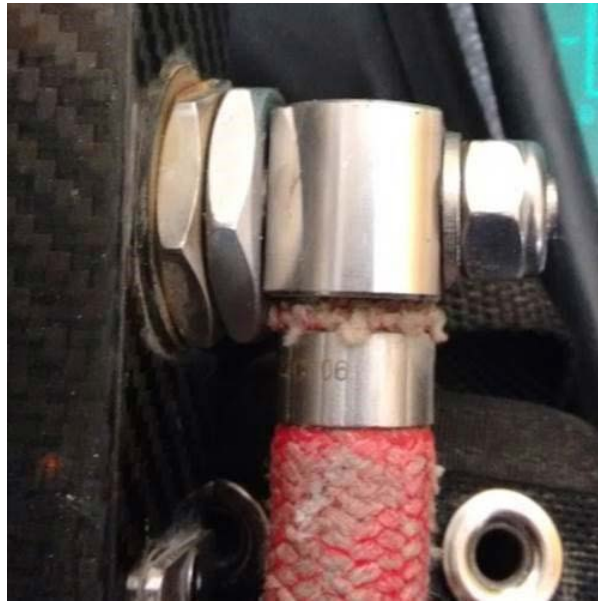
Figure 2 - Hot Water Hose in Position Showing Nyloc Nut
