## ADVISORY NOTICE

### ISSUE 1

#### **Diver occasionally experiences insufficient gas on initial activation**

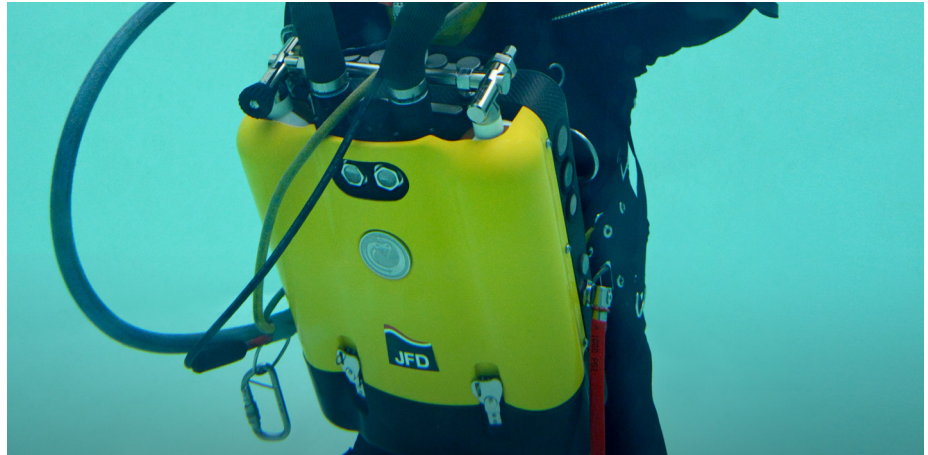
During standard operations, the counterlungs on the COBRA set are fully inflated when the set is in standby mode. This provides the diver with sufficient gas for his initial breath.

However JFD acknowledge that the time taken for the diver to fully activate the set with full engagement of the mouthpiece, determines the initial volume of gas available from the counterlungs, as any delay during the activation in this action will cause gas to vent from the counterlungs into the helmet and be unavailable to the diver.

#### **To ensure access to all of the gas available, the diver must activate the set swiftly and get the mouthpiece into his mouth to seal the breathing loop.**

The demand valve on the COBRA set is intended to provide any additional gas which is required by the diver at any time. However the demand valve may not provide sufficient flow for a large initial breath. The gas will come through, but not at the rate that the diver is perhaps expecting. After the initial breath, there is sufficient gas in the breathing loop and the diver will feel no further restriction.

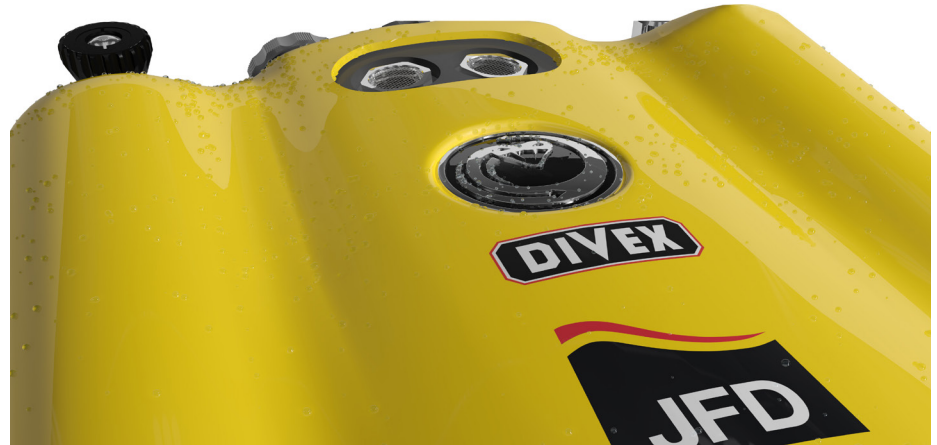
#### **Divers experience significant over-pressure on ascent to bell (hamster cheeks)**

This is a common effect with a semi-closed rebreather. The gas which is being constantly added and the gas expansion due to the ascent have to be vented from the relief valves in the back of the set.

When the diver is ascending, the height difference between the relief valves and the helmet is at its maximum. The pressure the diver experiences on his face is equal to the relief valve setting plus the height difference.

**When discomfort is experienced, the diver should vent excess gas from the side of his mouth or his nose. The mouthpiece must remain in the diver's mouth at all times. A seal between the mouthpiece and the diver's mouth must be maintained at all times except when the diver needs to vent excess gas.**

If the diver releases the mouthpiece, the counterlungs will vent to the hat. Upon engaging the mouthpiece again and trying to breathe, the diver may experience a shortage of gas as detailed in issue 1. Additionally, if the mouthpiece is not engaged in the divers mouth, the COBRA set may freeflow leading to rapid depletion of the onboard gas.
