COBRA Guidance Note

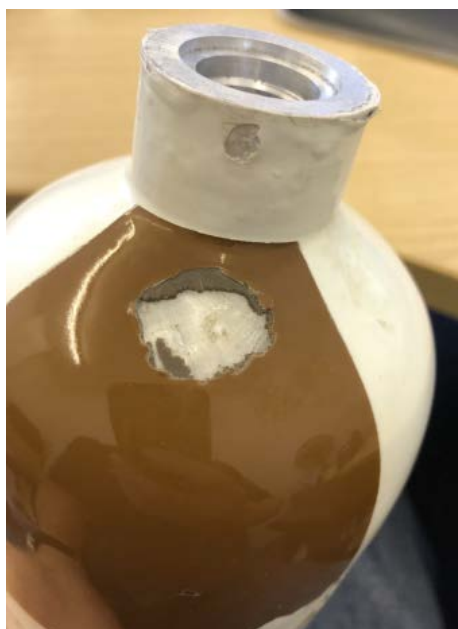
1. The user reported blistering and flaking of the lacquer on the cylinder exterior.
2. The user reported premature, excessive corrosion on the exposed aluminium at the cylinder neck.

Figure 1 - Flaking External Lacquer

JFD has investigated and worked closely with the cylinder manufacturer (Worthington Industries) who have categorically stated that flaking of the lacquer is a known but trivial characteristic of composite cylinders. The typical cause is due to air, which is trapped in the composite matrix during manufacture, being forced out during cylinder charging. It is thought that use in a hyperbaric environment can cause this issue to re-occur due to helium migrating under the lacquer over a period of time and then expanding when the set is removed from the dive system.

The manufacturer has explicitly stated that the voids are too small to allow any water ingress at diving pressures.

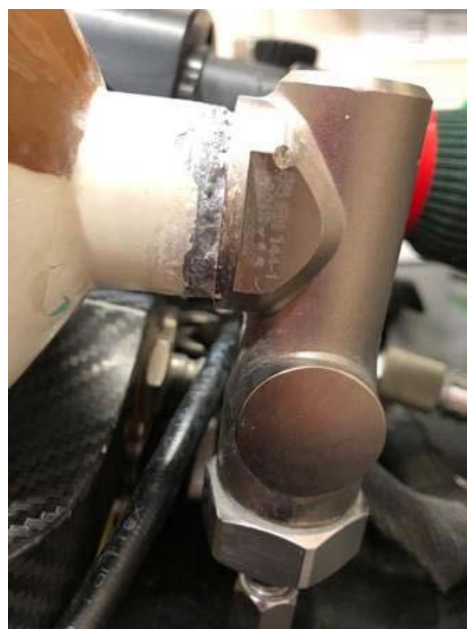
Figure 2 - Excessive Corrosion at Cylinder Neck

JFD carried out an evaluation of the cylinders in question which were certainly corroded beyond what was acceptable for the time in service and, in fact, subsequently failed inspection at an IDEST facility. JFD has contacted the manufacturer to investigate the possibility of a problem with this particular batch of cylinders. To date, the manufacturer has not responded with any information. Your ongoing understanding and support in this matter is much appreciated.

JFD advises users to check the external condition of the COBRA cylinders every time the COBRA set is removed from the dive system for maintenance, recharging or any other reason. If the cylinder condition is deemed questionable, a replacement should be fitted and the cylinder inspected by an IDEST facility, or similar nationally approved body in the relevant jurisdiction, before re-use.

Additionally, JFD are currently investigating the possibility of supplying a different brand of composite cylinder which has a stainless steel liner. This should eliminate all corrosion issues.
