COBRA Guidance Note

Background

Clients have reported cracking on the COBRA Head and Upper Plenum at the pockets for the M8 inserts.

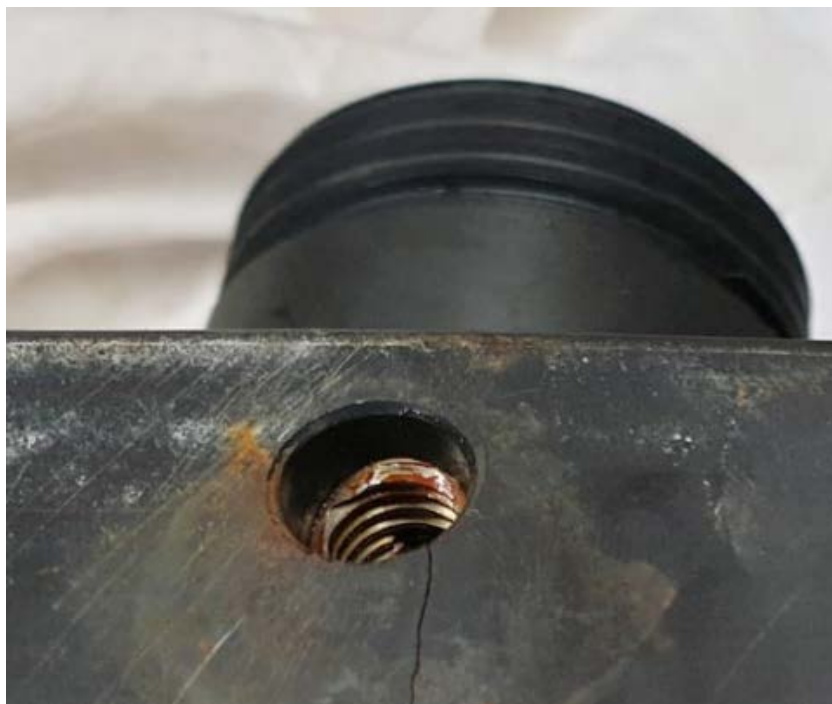
Figure 1 - Cracking at insert pocket

More recently, a client reported the issue on a newly supplied COBRA set and also provided information that identified the cause was an overly long cap screw bottoming out on the back of the insert pocket.

When users are changing these capscrews, they should also check for damage such as is shown in Figure 1. Any cracking found should be reported to JFD, along with photos. Replacement parts will be made available in cases where it is deemed necessary.

JFD will supply a 16mm length cap screw to all COBRA users which will resolve the issue. The screws in the locations marked in Figure 2 should be removed and discarded and the replacements fitted. Torque to 25 inch-pounds.

This issue may not require the user to immediately stop diving. Users should assess the mechanical security of the COBRA head and Scrubber Housing. If these items are found to be sufficiently secure, the user may choose to continue diving until a convenient time to perform the necessary work. JFD would expect to receive any requests for replacement items within approximately 6 months.
