## COBRA Guidance Note

JFD have had reports of the Handle Manifold becoming loose within the Activation Assembly on the Helmet

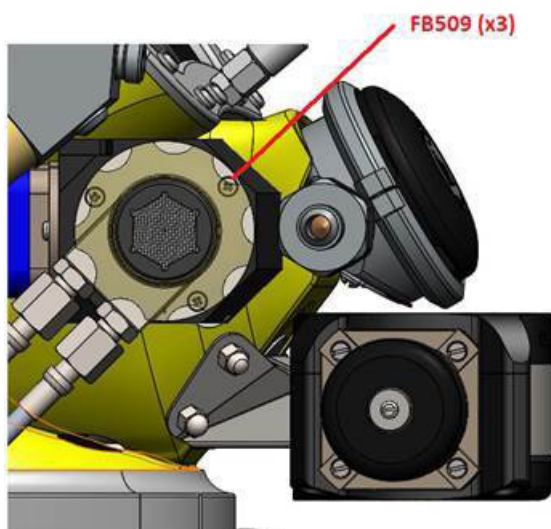
After repeated use, the M3 countersunk screws (pt. no. FB509) used to secure the Handle Manifold can loosen and occasionally unscrew completely, leaving the Handle Manifold insufficiently secured into the Mouthpiece Housing on the helmet.

The general torque stated in the COBRA manual for an M3 screw in a Tappex insert is insufficient in this location. These 3 screws (pt. no. FB509) should be tightened to 8 inch-pounds. Additionally, Loctite 222 should be applied to the countersink area of the screw only. It is important that the Loctite is not applied to the thread of the screw, as this may cause slackening of the insert when the screw is removed.

It can also be advantageous to remove the Activation Handle to allow improved access to these screws.
