## CAUTION NOTICE

No. DVX001/2010

## Caution Notice No. DVX001/2010 SLS Cylinder Sealing Surfaces

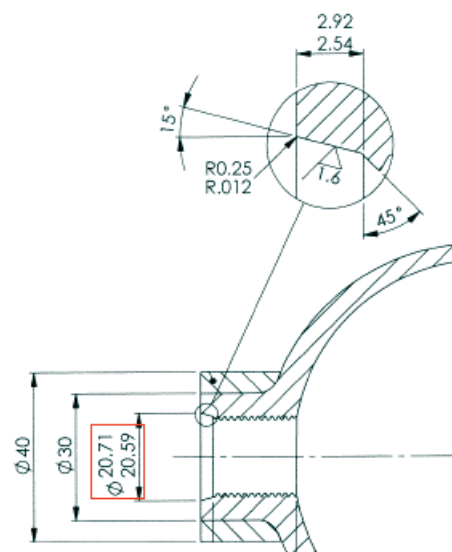
Fig 1

It is advised that a visual inspection must be carried out on the cylinder / manifold interface, to verify that the sealing surface detail is correctly machine to drawing (see Figure 1). Figures 2 and 3 on the following page highlight the difference between cylinders that have correct and incorrect sealing surfaces as they are assembled with the manifold.

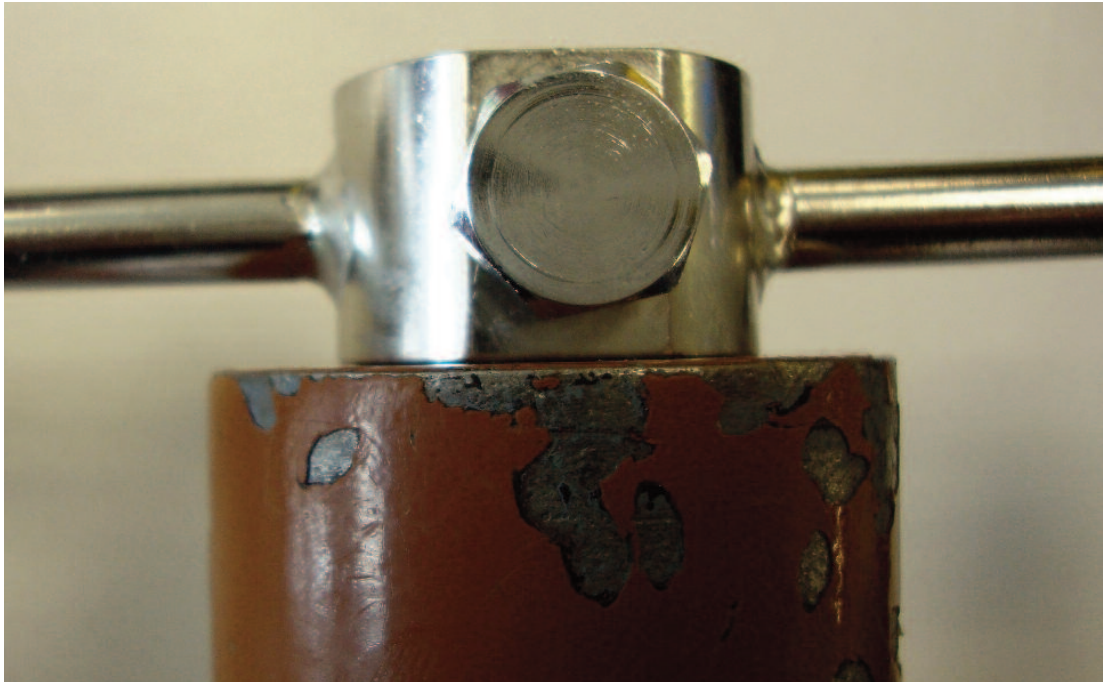
The manifold and cylinders should be removed from the backpack for visual inspection. If the cylinder neck butts directly up to the manifold and fully encapsulates the o-ring it is correct. If there is a gap visible between the cylinder neck and manifold it is incorrect.

**Fig 2** Correct cylinder / manifold assembly

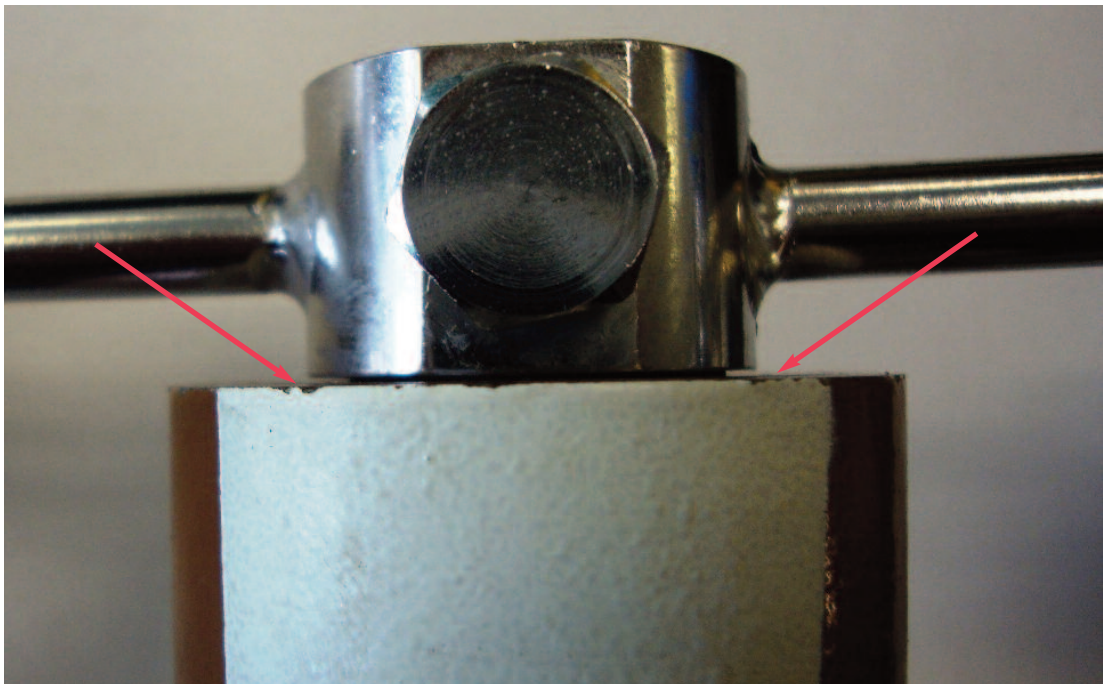
Recent production of SLS MKIV systems highlighted that a particular batch of M275 cylinders included some with undersized sealing surfaces. This can prevent the cylinder from being screwed fully onto the manifold. In such cases the cylinder does not butt directly up to the manifold and the o-ring is not fully encapsulated. It can compromise the integrity of the gas system if the o-ring is damaged by the cylinder thread as it is squeezed into the undersized cavity.

**Fig 3** Incorrect cylinder / manifold assembly

If the cylinder cannot be screwed smoothly onto the manifold until it there is no visible gap the cylinder should be removed and o-ring RN908-7 inspected for damage. Damaged o-rings suggest the cylinders have met and overcome excessive resistance while being screwed onto the manifold.

- Please contact Divex and quote this Caution Notice ref#.
- Advise Divex how many parts detailed in this Divex Caution Notice you have found faulty.
- Divex will advise you of an RGA number to use for the return.
- Replacement cylinders will be sent to you from Divex by return.
- Return your faulty cylinders to Divex.
