COBRA Guidance Note

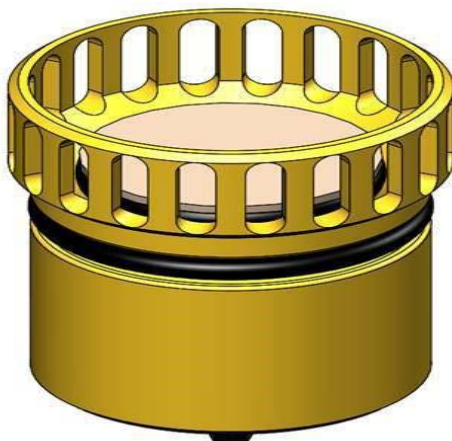
Figure 1 - Internal Exhaust Valve

Investigations found that due to the period of inactivity, both the internal and external exhaust valves (Figures 1 and 2) had become sticky and did not vent at the correct pressure.

If users also experience this problem, the relief valves should be removed from the COBRA set, cleaned and refitted.
