COBRA Guidance Note

A client has reported that the top handle on a COBRA set failed while the set was being hoisted.

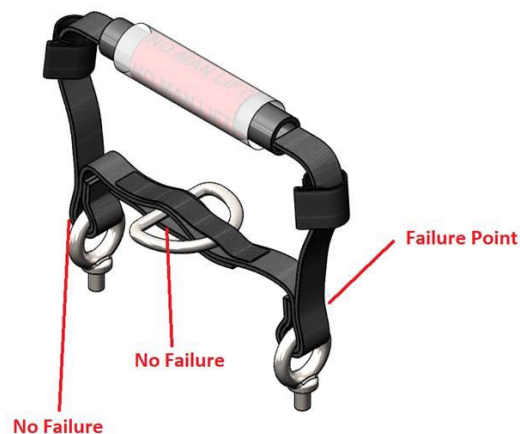
The top handle on a COBRA set failed while the COBRA set was being lifted or lowered on a pulley system.

The stitching was found to have failed at one eyebolt. The COBRA set dropped but the other eyebolt and the D-ring remained connected to the COBRA set.

Users are reminded to check the condition of the handle and stitching before any lifting operation and to clip the lifting tackle into the D-ring as intended.

As a result of user feedback, JFD will shortly be reviewing the handle arrangement and will communicate any changes / improvements via a further guidance note.
