COBRA Guidance Note

Leakage at the joint between the Y-piece and the interface block

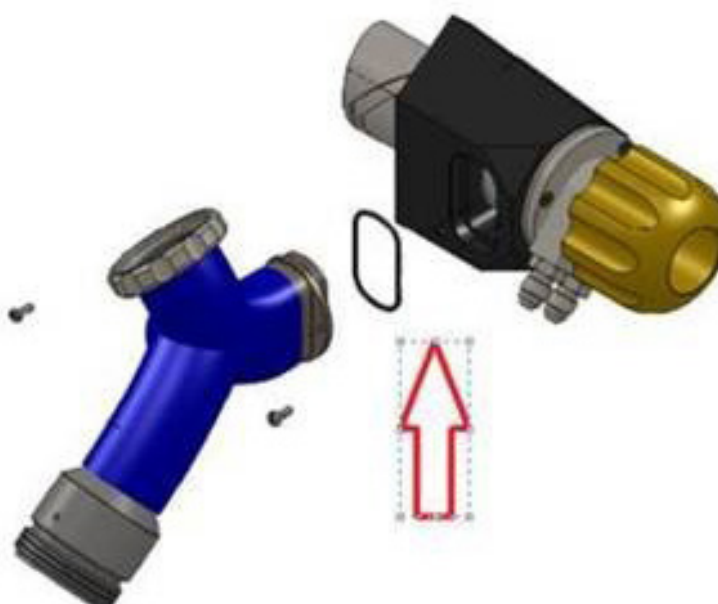
The joint between the Y-piece and the interface block on the COBRA helmet uses an o-ring seal. Additionally, the joint is coated with silicone RTV as a back-up measure. Although this joint has performed satisfactorily, there have been occasional reports of gas leakage in this area, especially if the helmet receives a knock or impact. The potential for leakage is increased because the spigot and bore are not circular, therefore any twisting at the joint tends to pull the o-ring away from part of the bore causing leakage.

Any time this leakage has been observed, it has been minor and the positive pressure in the COBRA set has prevented water ingress.

Figure 1 - Joint between the Y-piece and interface block with o-ring seal

A replacement o-ring has been identified, that has a larger cross section but a smaller internal diameter. This increased volume of sealing material fills the joint more fully, preventing any leak even if the Y-piece is substantially manipulated. It is not necessary or recommended to use silicone RTV in conjunction with this new seal.

To fit the new seal, disconnect the helmet hose from the Y-piece and remove the clamp holding the Y-piece to the helmet. Remove the two screws fixing the Y-piece to the interface block. Withdraw the Y-piece, discard the o-ring and clean all silicone from the bore and the spigot.

Stretch the new o-ring over the spigot, lubricate and refit the Y-piece to the interface block, pulling the items together using the fixing screws. Refit the other parts, remembering to seal the clamp screws with silicon RTV where they pass through the helmet shell.

Replacement o-ring part number RN0813-7. These will be made available to users on request.
