COBRA Guidance Note

Background

Some users have been reporting bulging of the COBRA demand valve diaphragm alongside difficulty setting the positive pressure.

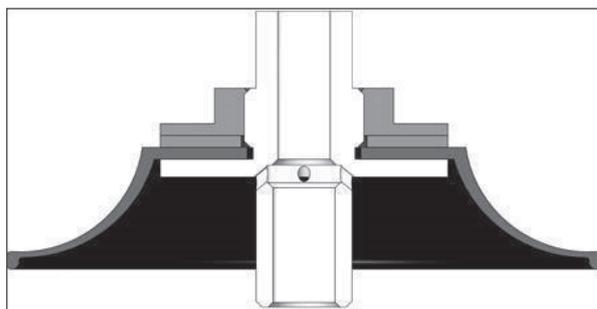
Figure 1 - Diaphragm Resting Shape

1. Firstly, it is necessary to determine whether the diaphragm is actually bulging or merely sitting asymmetrically. Bulging is defined as having any protrusion beyond the shape developed by the diaphragm when the set is in standby mode and gas is venting from the external relief valves (due to lightly purging the demand valve). If any bulging is evident, the diaphragm must be replaced.

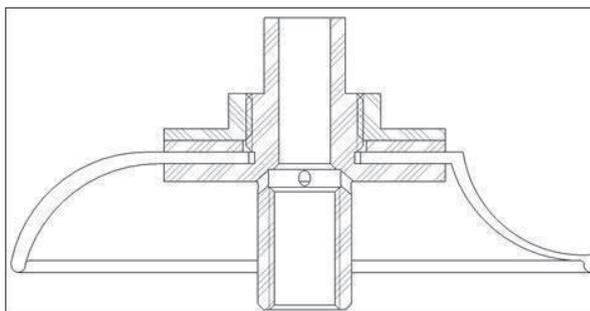
Figure 3 - Acceptable Asymmetric Shape

If the diaphragm is sitting asymmetrically, this is not a problem in its own right. If a stable positive pressure can be achieved, it is perfectly acceptable to use the COBRA set. In use, the diaphragm is clamped at the circumference and pulled down in the centre. Depending on the inherent stiffness of the individual diaphragm, the positive pressure acting on the underside of the diaphragm may or may not be sufficient to cause the flexible section of the diaphragm between the edge and the centre to adopt a fully convex shape.
