DIVEX HSE ALERT						
(. <u>HSE002</u>			Divex Ltd. Enterprise Drive Westhill, Aberdeen	
	INCORRECT FITTING OF VALVE IN GAS LINES					AB32 6TQ, United Kingdom Telephone +44 (0)1224 740145 Facsimile +44 (0)1224 740172 e-mail info@divex.co.uk	
	DATE	12/04/07	COUNTRY:	AUSTRALIA	LOCATION:	DIVEX ASIA PACIFIC. PERTH

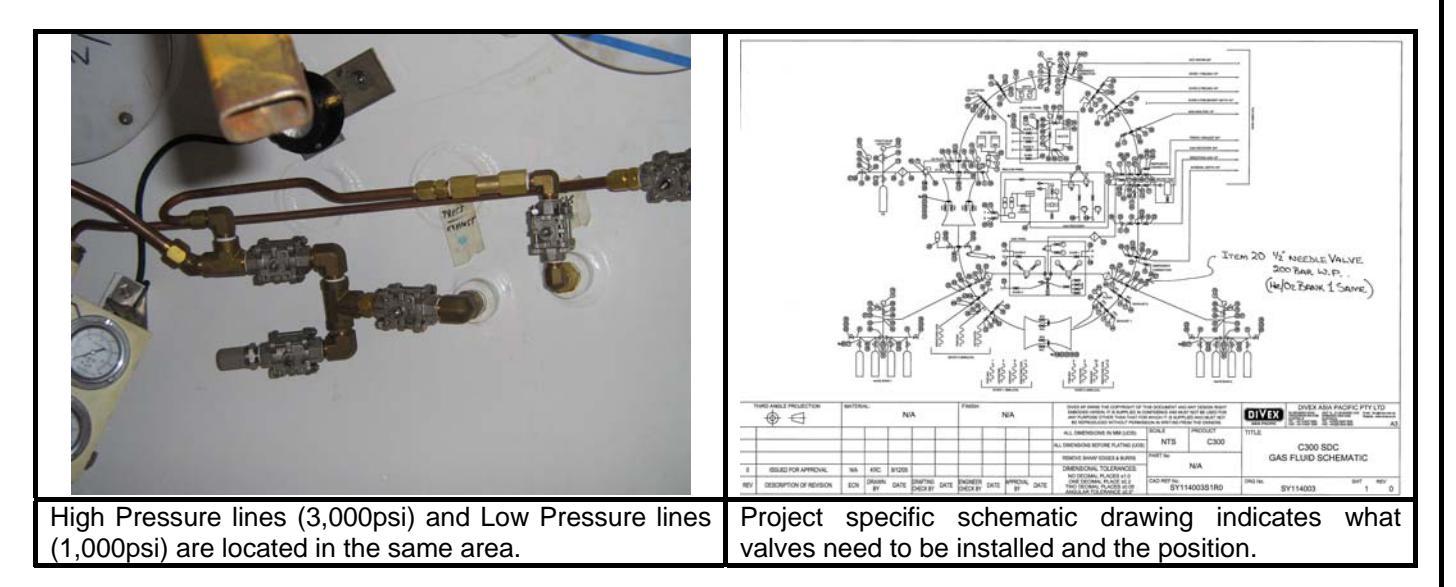
A potential Divex Asia Pacific (DAP) incident was avoided where inspections picked up the instalment of a 1,000psi ball valve where the drawing stipulated a 3,000psi needle valve. The valve had previously passed final inspection, system testing and an independent 3rd Party audit of the system. The photos below highlight what was found as a result of the inspection:

- The lines involved were "Onboard Gas Supply Line (25% O₂ and 75% Helium) internal;
- It is acceptable engineering practice to have ball valves in these types of lines;
- Technician involved was inexperienced in Divex Asia Pacific systems and made a human error;
- There was a lack of Supervision of a Technician that had recently joined Divex Asia Pacific;
- The incorrectly fitted internal valves were not picked up through the Divex Asia Pacific final inspection;
- The incorrectly fitted internal valves were not picked up through the independent 3rd Party System Audit;
- If the same incorrect valves had also been fitted externally the internal incorrectly fitted valves would
 probably have been picked by both Divex Final Inspection and 3rd Party Audit.

- The incident was reported as a near miss within the Divex HSE Management System;
- The Technician and Project Manager were involved in a full incident investigation;

- All new Divex Asia Pacific Technicians need to be trained in Divex Production Procedures GEN-WP-001, 002, 003 and 009;
- A Divex gap analysis must be conducted of new employee competence levels upon employment and the level of training and supervision needs to be determined and provided;

- All gas lines need to be identified either by numbering or colour coding and have suitable valve identification through use of identification plaques preferable indicate pressure ratings;

- Divex Production Managers shall discuss this incident at Production / Operations Meetings;
- Technicians must pay attention to valves being fitted when signing off the AITP;
- Divex personnel need to also make sure that pressure related items such as valves, hoses and hose fixings are checked to ensure they are the correct rating and are fit for purpose.
