COBRA Guidance Note

Background

Clients have reported cracking on the COBRA Head and Upper Plenum at the pockets for the M8 inserts.

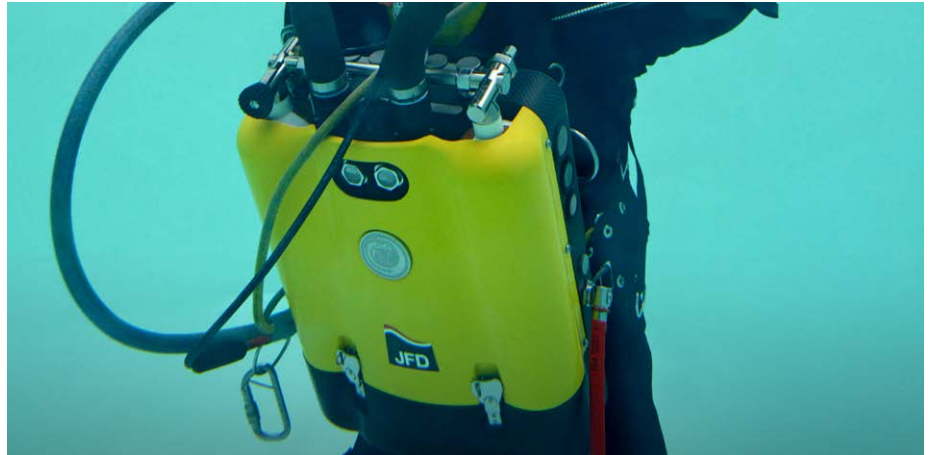
More recently, a client reported the issue on a newly supplied COBRA set and also provided information that identified the cause was an overly long cap screw bottoming out on the back of the insert pocket.

JFD will supply a 16mm length cap screw to all COBRA users which will resolve the issue. The screws in the locations marked in Figure 2 should be removed and discarded and the replacements fitted. Torque to 25 inch-pounds.

When users are changing these capscrews, they should also check for damage such as is shown in Figure 1. Any cracking found should be reported to JFD, along with photos. Replacement parts will be made available in cases where it is deemed necessary.
