COBRA Guidance Note

Leakage at the joint between the Y-piece and the interface block

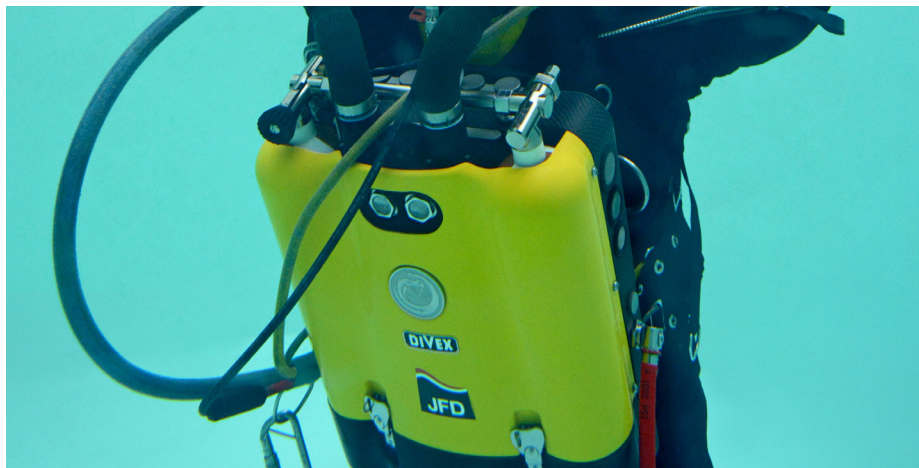
JFD have had reports that leakage has occasionally been observed at the joint between the Y-piece and the interface block.

The joint between the Y-piece and the interface block on the COBRA helmet uses an o-ring seal. Additionally, the joint is coated with silicone RTV as a back-up measure. Although this joint has performed satisfactorily, there have been occasional reports of gas leakage in this area, especially if the helmet receives a knock or impact. The potential for leakage is increased because the spigot and bore are not circular, therefore any twisting at the joint tends to pull the o-ring away from part of the bore causing leakage.

Any time this leakage has been observed, it has been minor and the positive pressure in the COBRA set has prevented water ingress.

A replacement o-ring has been identified, that has a larger cross section but a smaller internal diameter. This increased volume of sealing material fills the joint more fully, preventing any leak even if the Y-piece is substantially manipulated. It is not necessary or recommended to use silicone RTV in conjunction with this new seal.

To fit the new seal, disconnect the helmet hose from the Y-piece and remove the clamp holding the Y-piece to the helmet. Remove the two screws fixing the Y-piece to the interface block. Withdraw the Y-piece, discard the o-ring and clean all silicone from the bore and the spigot.

Replacement o-ring part number RN0813-7. These will be made available to users on request.
